# Assessment of Dam Safety Coal Combustion Surface Impoundments Draft Report

American Electric Power  
General James Gavin  
Power Plant  
Cheshire, Ohio

July 2, 2009

CHA Project No. 20085.4000.1510

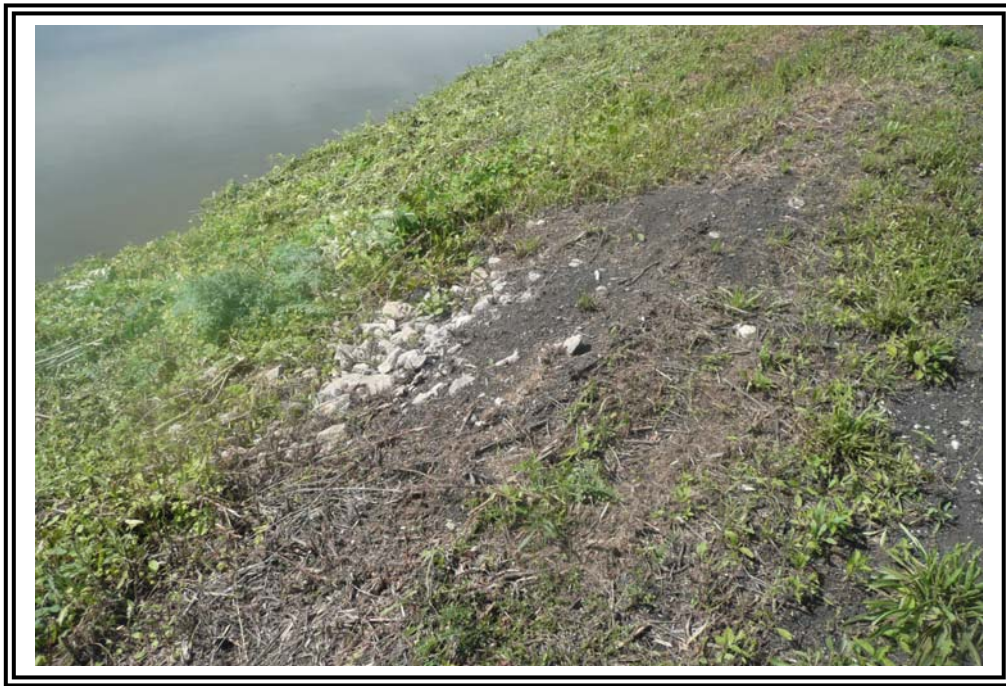
Along the west dike there are several signs of previous surface erosion features. AEP has repaired these as they occur. Photo 2 shows one of these repaired areas.

Erosion feature filling on the upstream slope of the west dike.

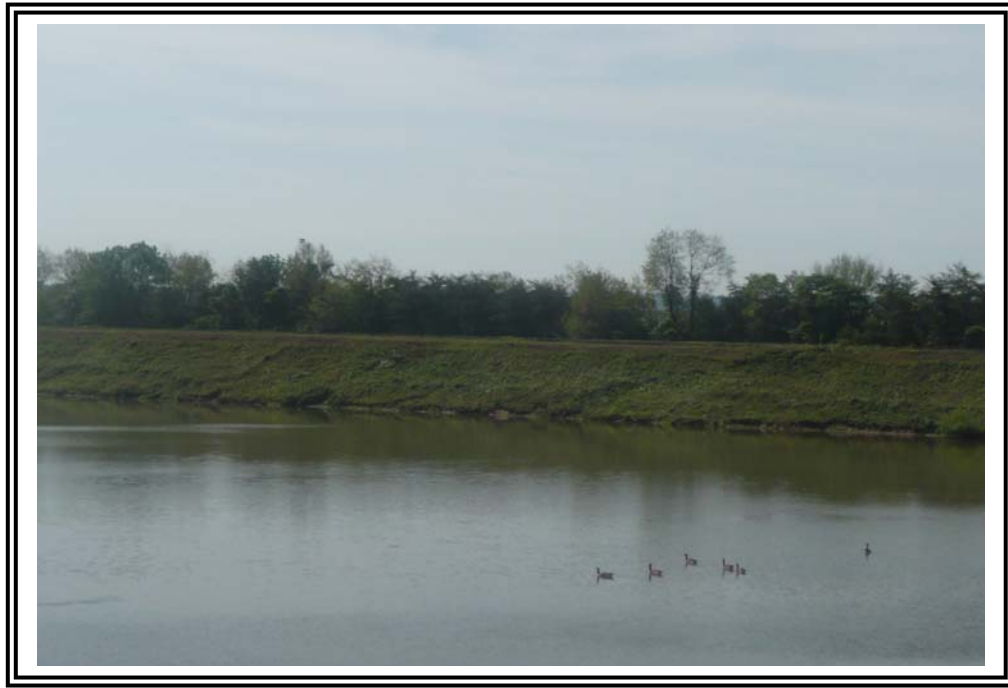
11

Upstream slope of the south dike, looking south. Note surficial sloughing.

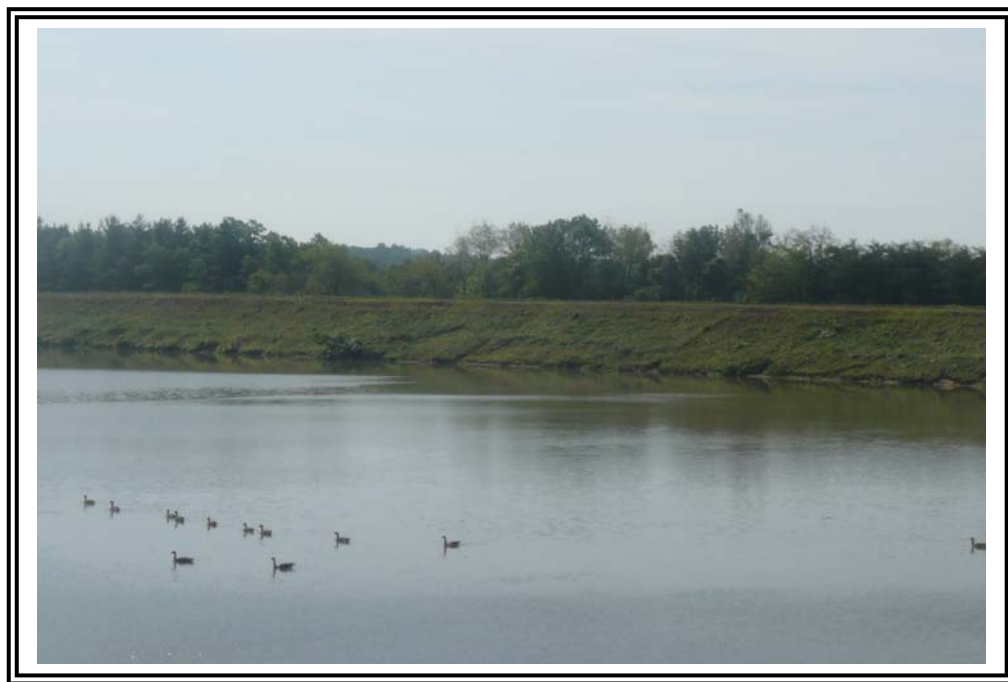
12

Upstream slope of the south dike, looking south. Note surficial sloughing.

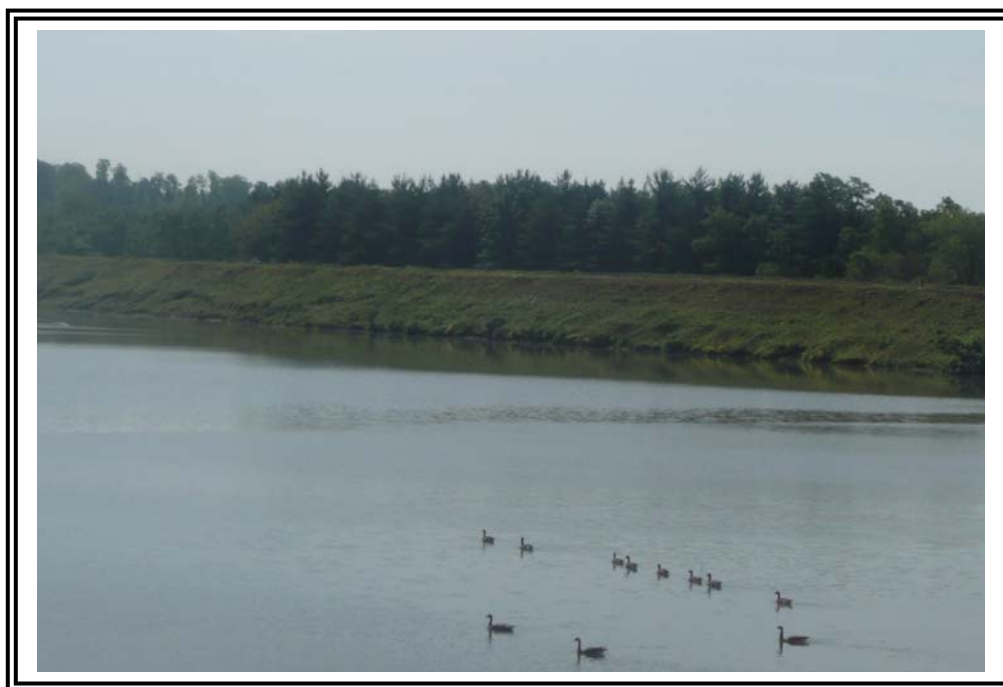
13

Upstream slope of the south dike, looking south. Note surficial sloughing.

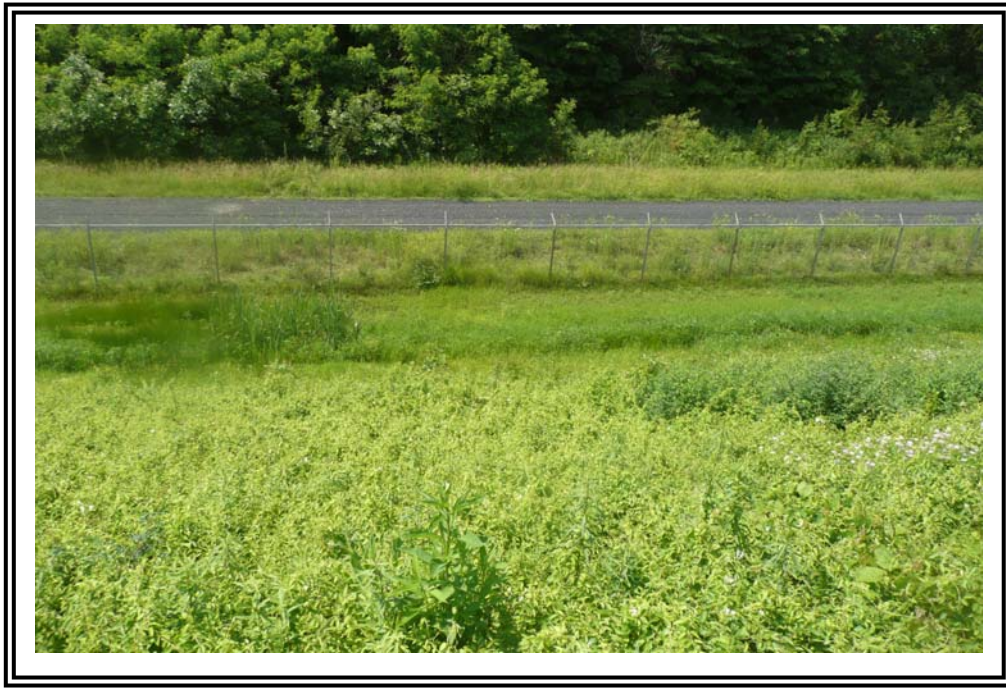
17

At about the mid point along the length of the south dike downstream slope, there is a wet area that has been noted in previous reports to be seepage. AEP personnel indicated that in February 2009 the storm water drainage from the field to the south of the Bottom Ash Pond was re-graded so rather than draining towards the Bottom Ash Pond, the runoff would run away from the Bottom Ash Pond. AEP indicated this appears to be largely improving the condition at the toe of the south dike. Piezometer readings indicate the groundwater table is about 18 feet below the toe of the south dike further suggesting that the observed water was perched on surface soil layers. No flow was observed in ponded water at the toe of the south dike.

Downstream slope of the south dike about mid-slope. Note cattails growing at the toe of the slope. This area has been reportedly a wet area, but AEP believes it is related to surface drainage and in the fall 2008 reset culverts crossing the adjacent access road to pitch away from the wet area and the conditions appears to be improving. Recent spring rains have resulted in standing water in this area.

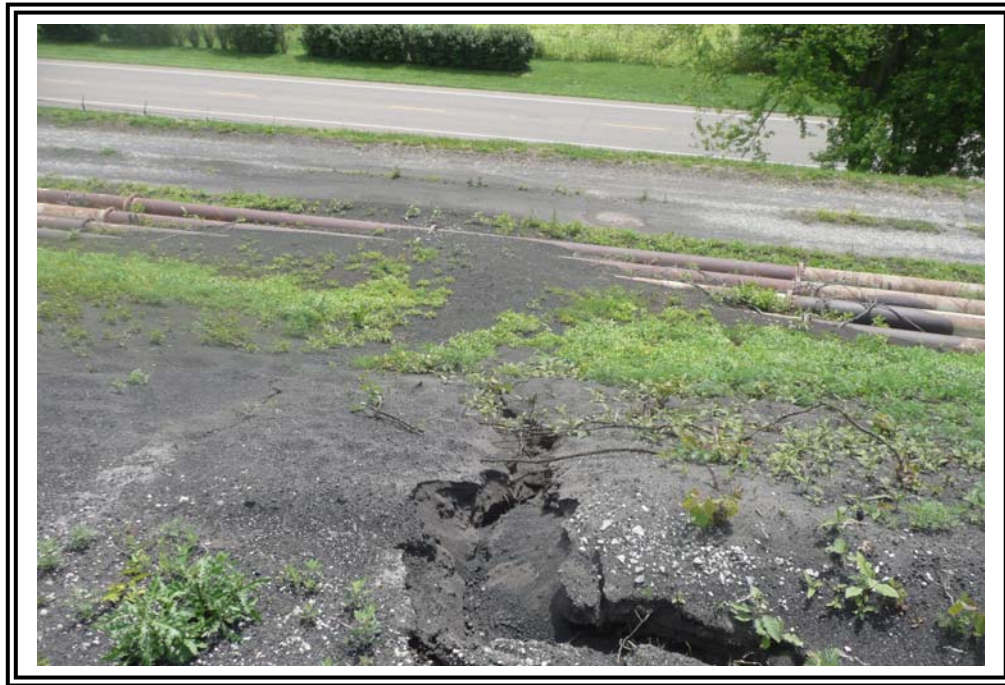
There were many areas of erosion gullies along the transition from the crest to the downstream slope. The deepest of these was 18 inches deep. There was evidence that the development of these is common and that AEP routinely repairs them as part of ongoing maintenance of the dikes. Photos 22 and 23 show a typical representation of these areas on the east dike.

Surface erosion features (typical) along graded ash at east dike upstream slope/crest transition.

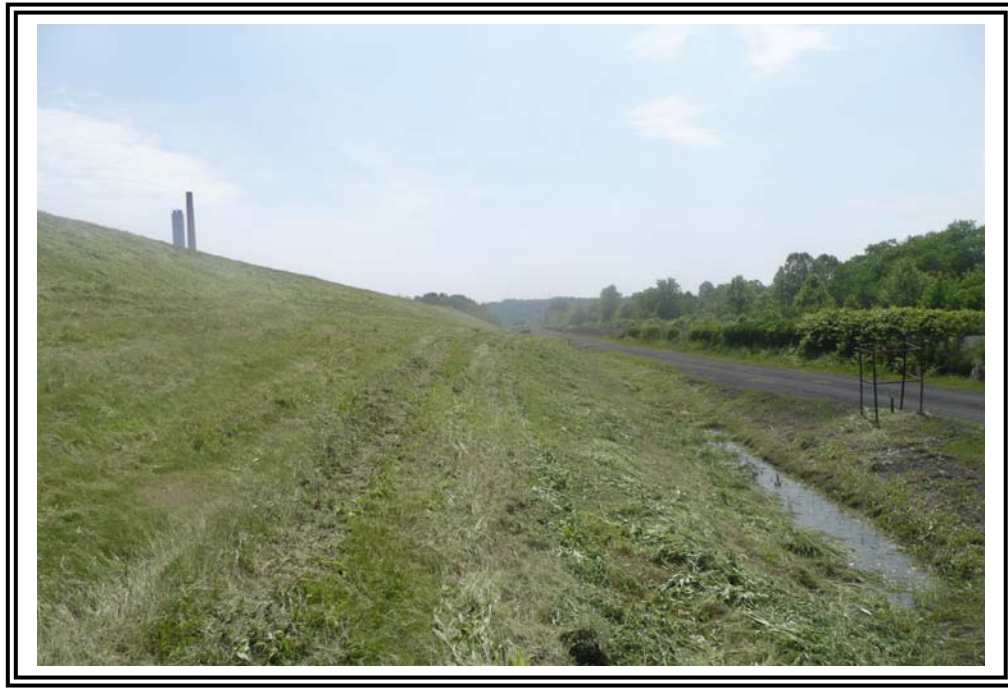
27

Previous reports indicated there is a bulge on the downstream slope of the west dike. CHA observed this area and did not see signs of current movement, nor an area above this slope where it appears that either the bulged soil came from or that the area was repaired. AEP should continue to monitor this area for changes as they have in the past.

Apparent bulge reported in previous reports along west dike. No signs of current movement.

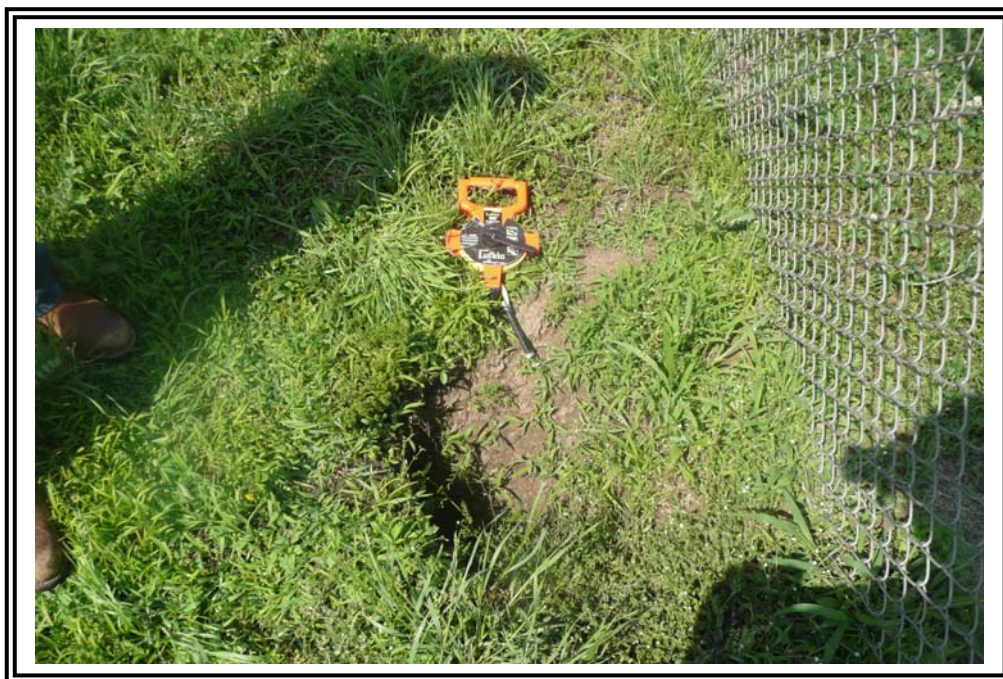
32

Along the east dike toe, several rodent holes were observed as shown in Photo 32. A few of these appeared to be plugged and AEP personnel indicated they have had to trap rodents from time to time. Some of the observed rodent holes may have been active, although it was difficult to distinguish.

Several rodent holes were noted on the downstream slope of the east dike. Some were plugged from previous AEP efforts to deter rodents and repair holes. Others were unidentifiable as active or abandoned holes.

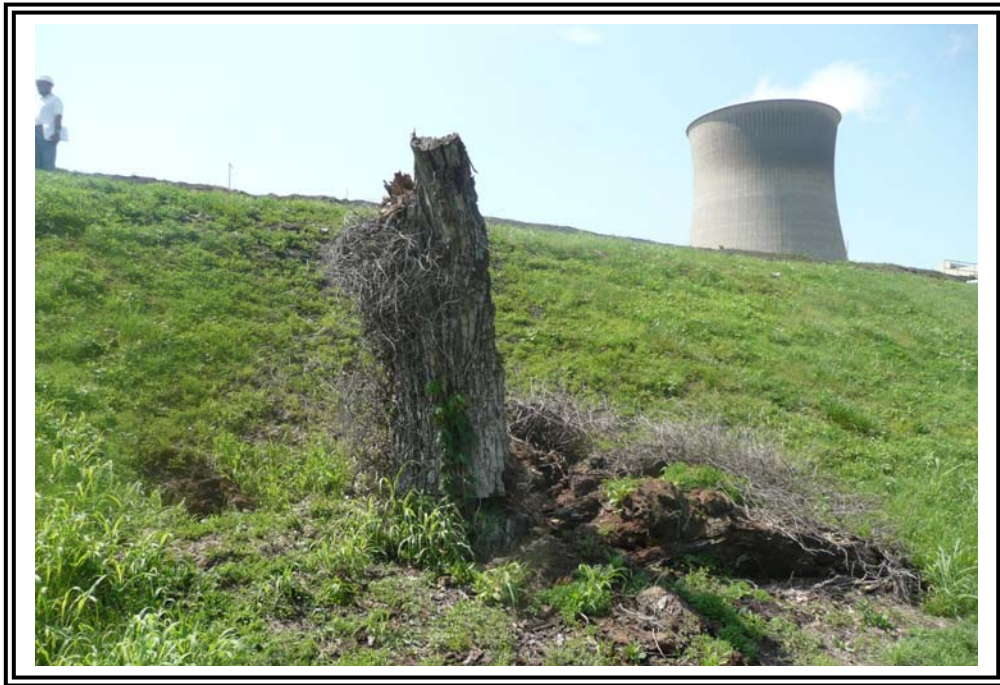
33

There are a few tree stumps along the toe of the east dike as shown in Photo 33. AEP personnel did not know when these trees were cut or why the bench with the access road was apparently constructed around them. These stumps should be monitored for decay and the stumps and associated root balls removed as a maintenance task in the next 2 to 5 years under the direction of a professional engineer.

Several tree stumps noted on the downstream slope of the east dike (others except this one were cut flush to ground surface). This is in the benched out area of the east dike.

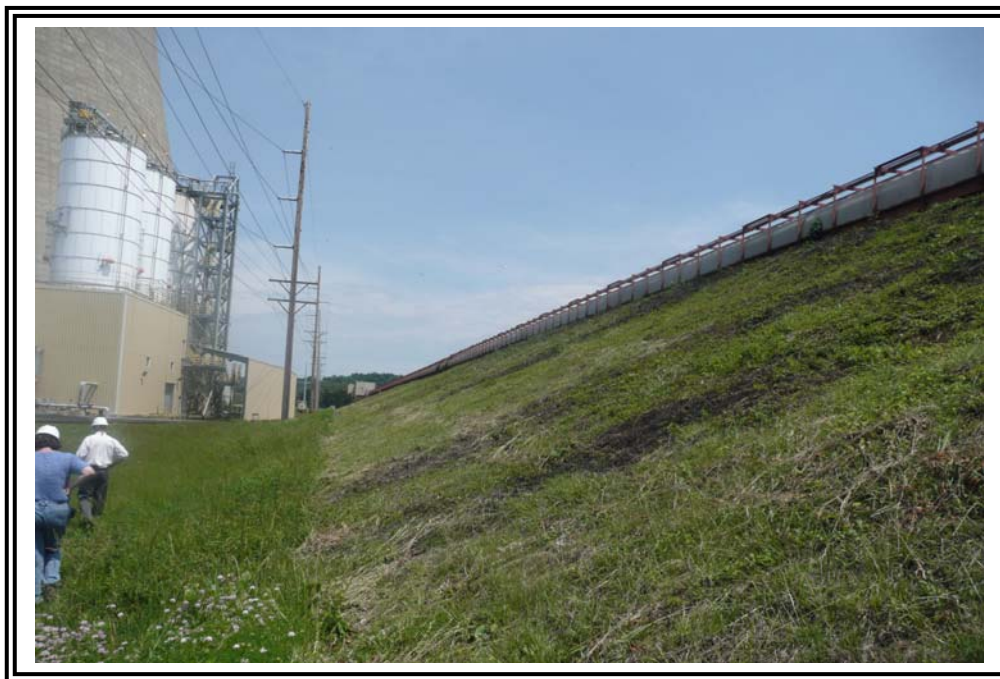
34

Downstream slope of north dike, looking east. Note dark areas in the grass on the slope are coal residue runoff from flushing the coal conveyor to remove dust buildup.

Along the Upstream Slope of the north dike, there are a few locations where various sumps from the plant area are discharged into the Pond. Most of these discharge pipes have concrete splash pads underneath these. Sections of Conveyor Belt have been placed over these because abrasion from particles in the discharge was degrading the surface of the concrete. Because of this covering and active flow, CHA could not observe the condition around these splash pads. CHA recommends that these areas be inspected as plant operation allows (i.e. when water is not flowing across the splash pads) to evaluate the concrete condition, and make sure flows are not eroding the adjacent soil of the dike.

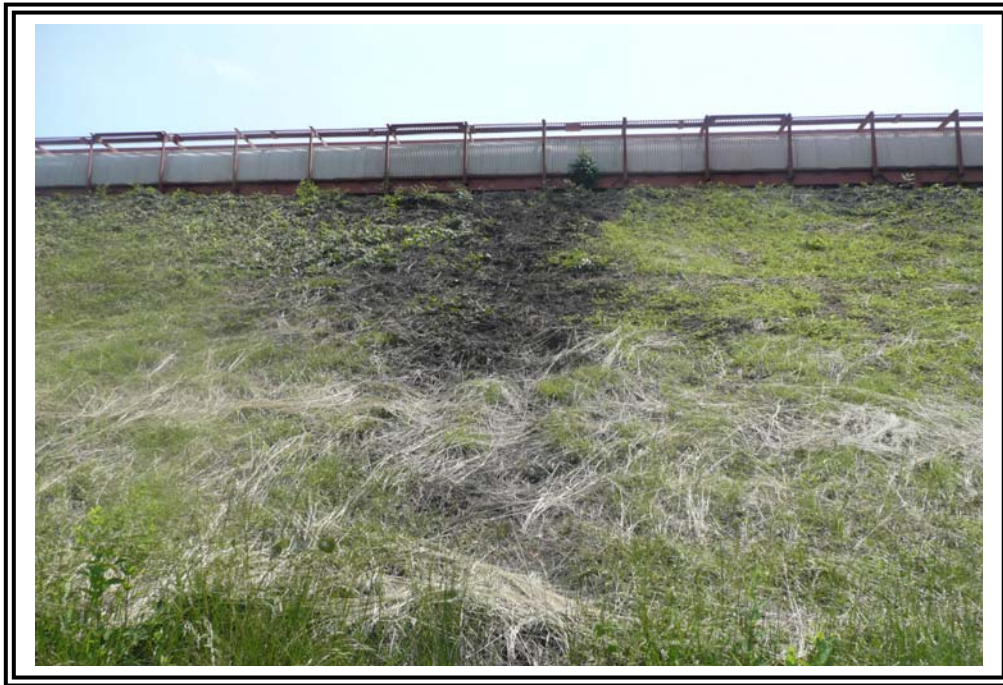
35

Close-up of one area of coal residue from coal conveyor flushing.

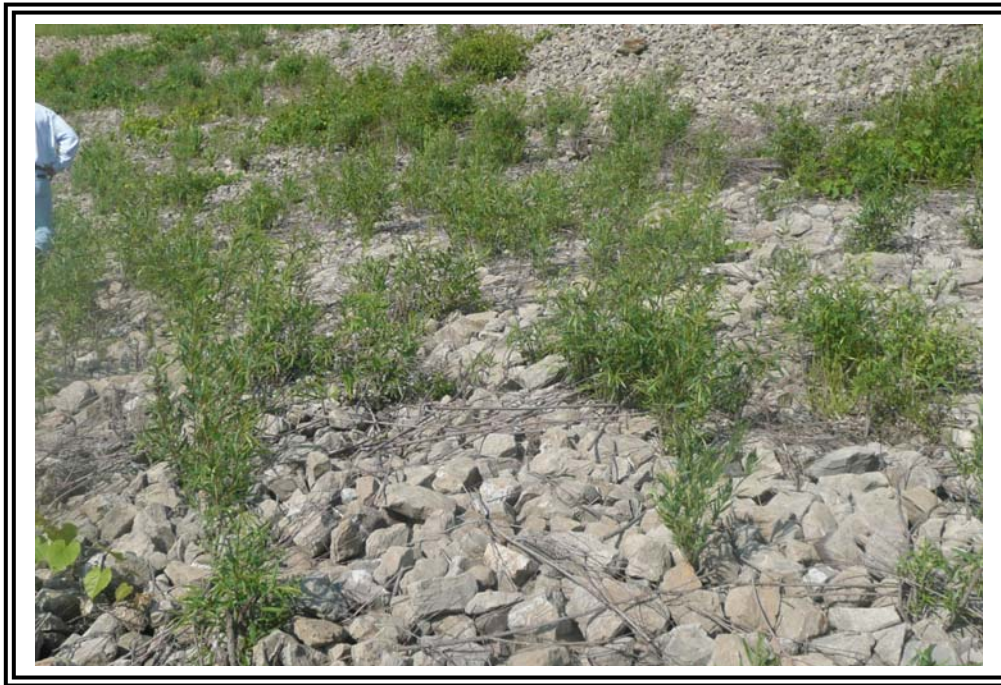
53

Vegetative growth within toe drain rip rap.

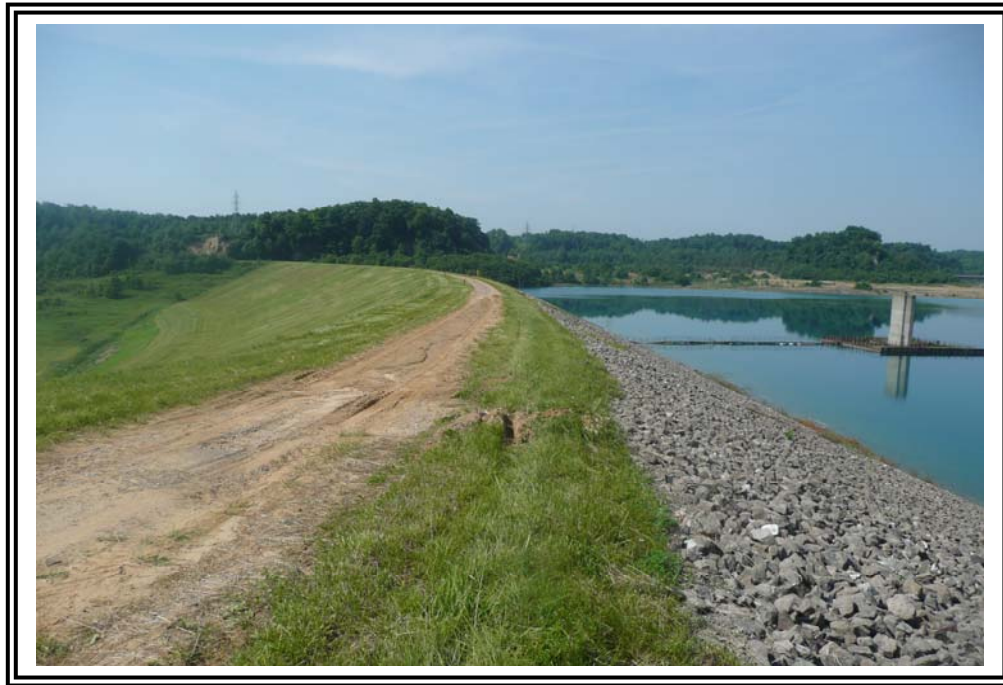
61

Dam crest from left (south) Abutment. Note area of tire ruts appears to be from wet area resulting from runoff from the abutment.

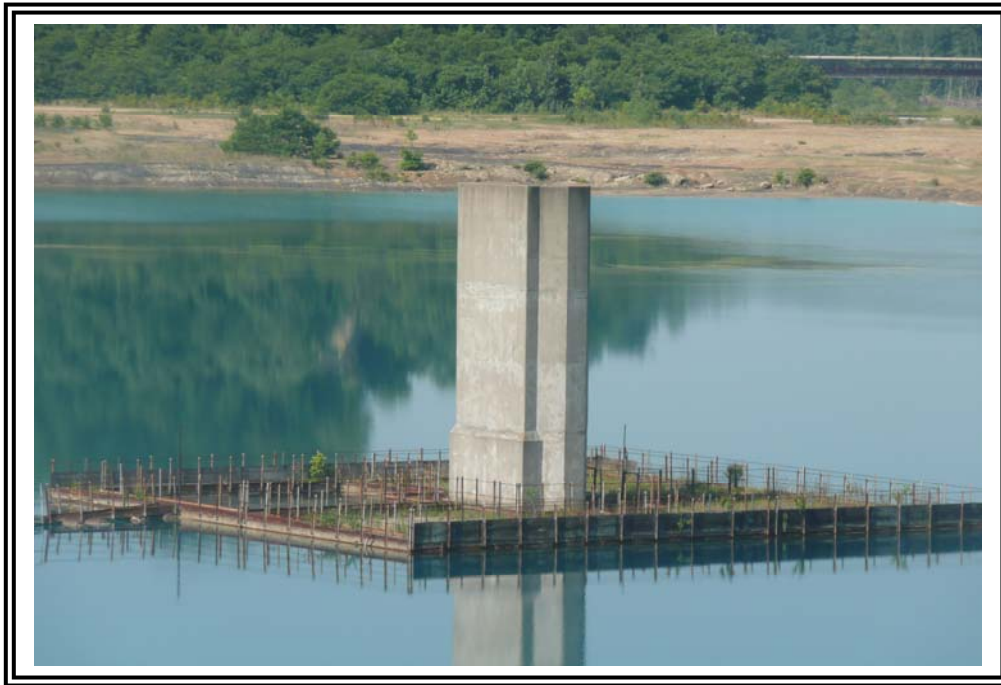
The Intake Tower in Stingy Run Dam was inaccessible at the time of our visit. The floating access bridge to the tower is severely deteriorated and AEP blocked it off in 2008. Photos 65 and 66 show the tower and access bridge.

The intake tower was inaccessible due to recent (spring 2009) closing of floating access bridge due to safety concerns.

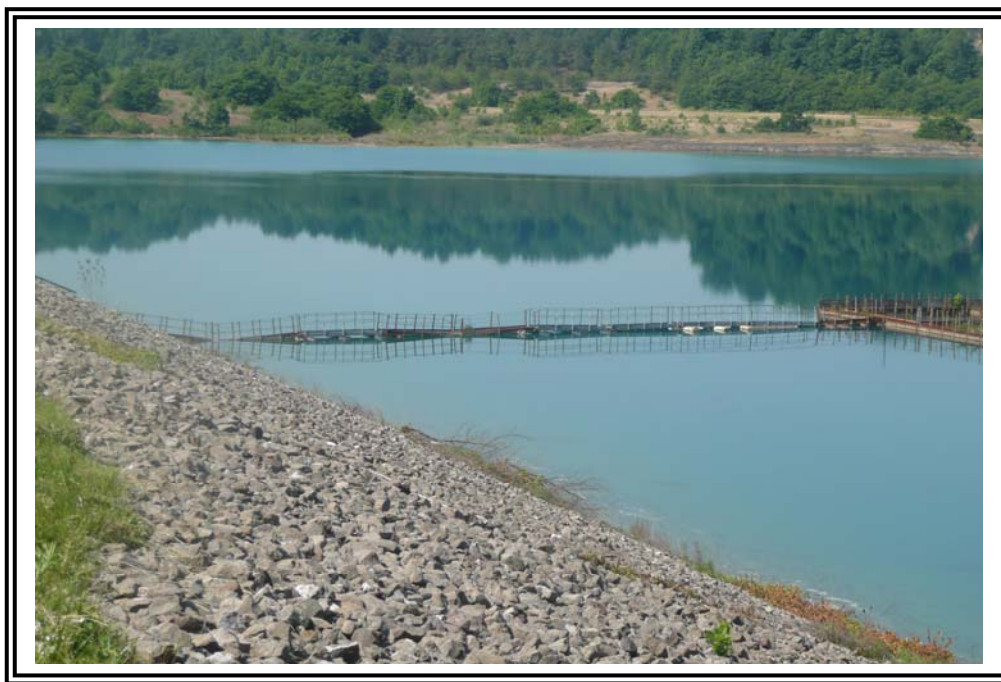
66

Floating Bridge to Intake Tower. Note the deteriorated condition of this structure resulted in AEP closing it in the spring of 2009.
